NASA/TM—2004-212303

# Durability Assessment of Gamma TiAl— Final Report

Susan L. Draper, Bradley A. Lerch, J. Michael Pereira, and Kazuhisa Miyoshi  
Glenn Research Center, Cleveland, Ohio

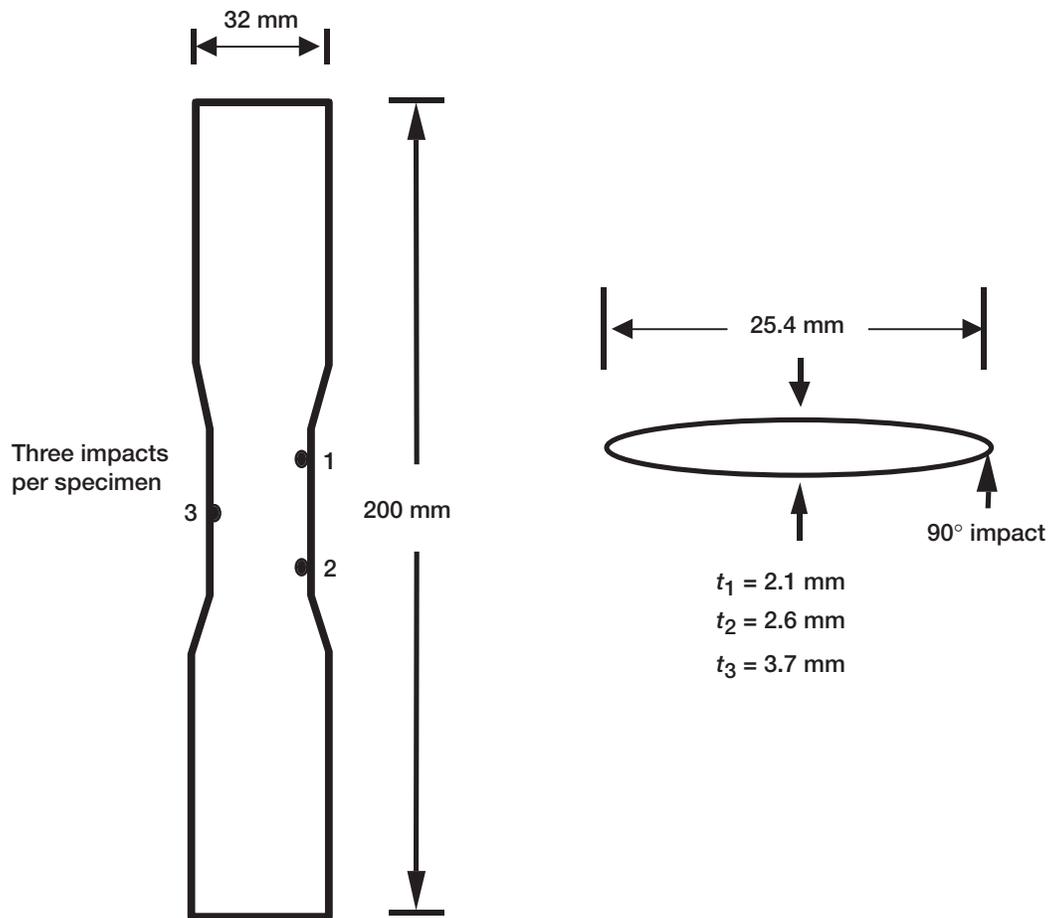
Figure 1.—Cast-to-shape impact specimen design. Center thickness of specimens is represented by  $t$ . Points 1, 2, and 3 represent the impact locations.

**Experiments.**—An effort was made to capture as much of actual engine conditions as possible in laboratory tests including casting the Ti-48-2-2 and ABB-2 specimens to shape with simulated leading edges of LPT blades. However, due to cost and availability issues, subsequent specimens were machined from cast or wrought plates into impact specimens. The samples were rough cut by electrodischarge machining (EDM) and then low-pressure ground to final shape. Every surface was ground to eliminate EDM damage.

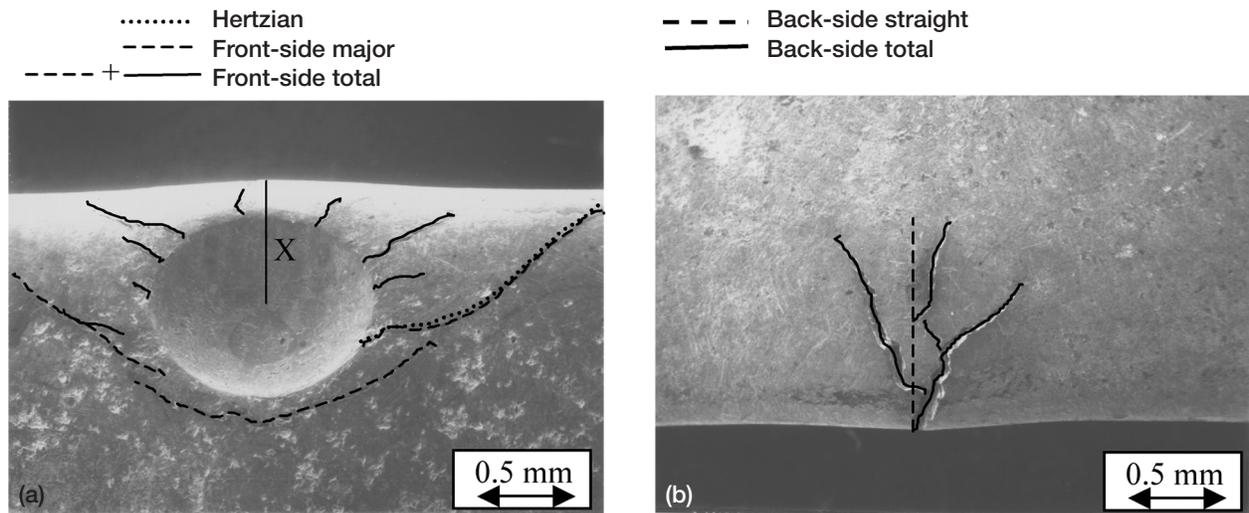
Figure 4.—Crack measurements for  $\gamma$ -TiAl. (a) Front side showing impact location, X. (b) Back side.

After impacting, the specimens were examined in a scanning electron microscope (SEM). Five types of crack lengths (fig. 4) were measured: (1) front side (FS) major, (2) FS total, (3) Hertzian (HZ), (4) back side (BS) straight, and (5) BS total. FS major is a summation of the largest, somewhat continuous crack observed on the front (impacted) side of the specimen while FS total is a summation of the length of all cracks observed. A HZ crack was defined as the longest crack on the impacted side of the sample that was at an angle from the impact to the specimen edge. A BS straight crack length is measured from the specimen edge to the end of any cracking on the back side of the impact, whereas BS total is a summation of all the crack lengths on the back side of the sample. In addition,  $X$  (see fig. 4) was measured.

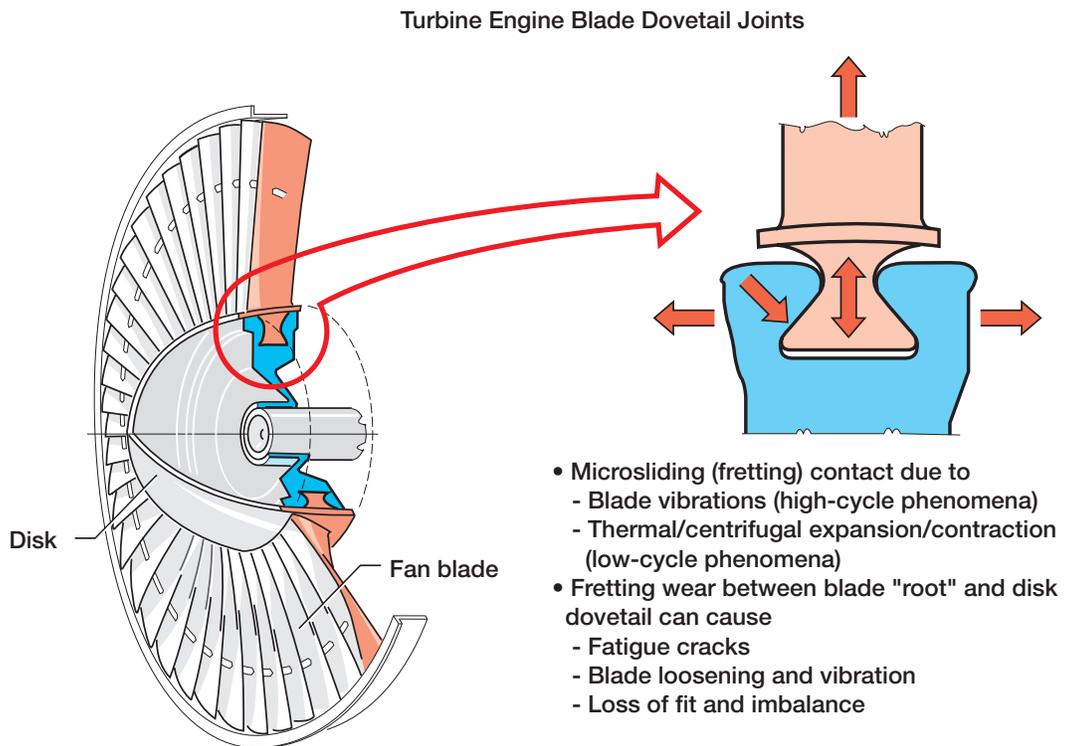
Figure 5.—Blade and disk dovetail configurations.

The initial application for  $\gamma$ -TiAl in aeroengines is for use as LPT blades. Since the blades are joined to the turbine disk in a dovetail arrangement (fig. 5), fretting is an obvious concern. Dovetail regions are often areas involving high wear. For example, observations of service-exposed Ti-based alloy fan blade-disk couples revealed the presence of severe fretting fatigue damage on the contacting surfaces of blade dovetails and disk slots (ref. 11).

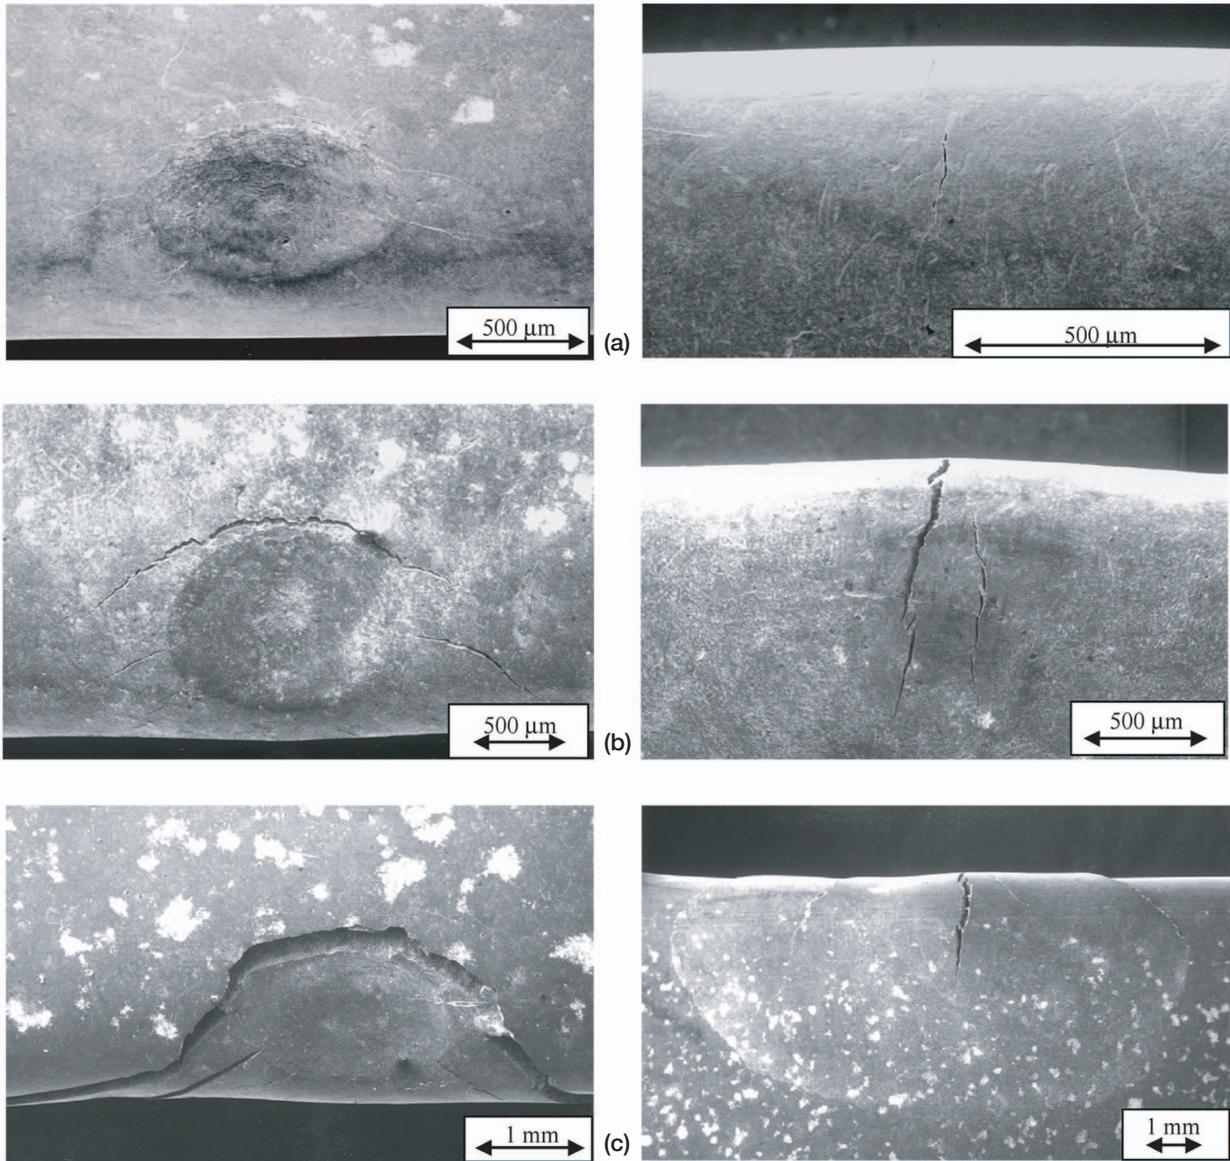
Figure 10.—Front-side (left) and back-side (right) cracking patterns on Ti-48-2-2 samples modeled in study. (a) Low-energy impact, 008-10-3. (b) Medium-energy impact, 005-08-3. (c) High-energy impact, 009-08-2.

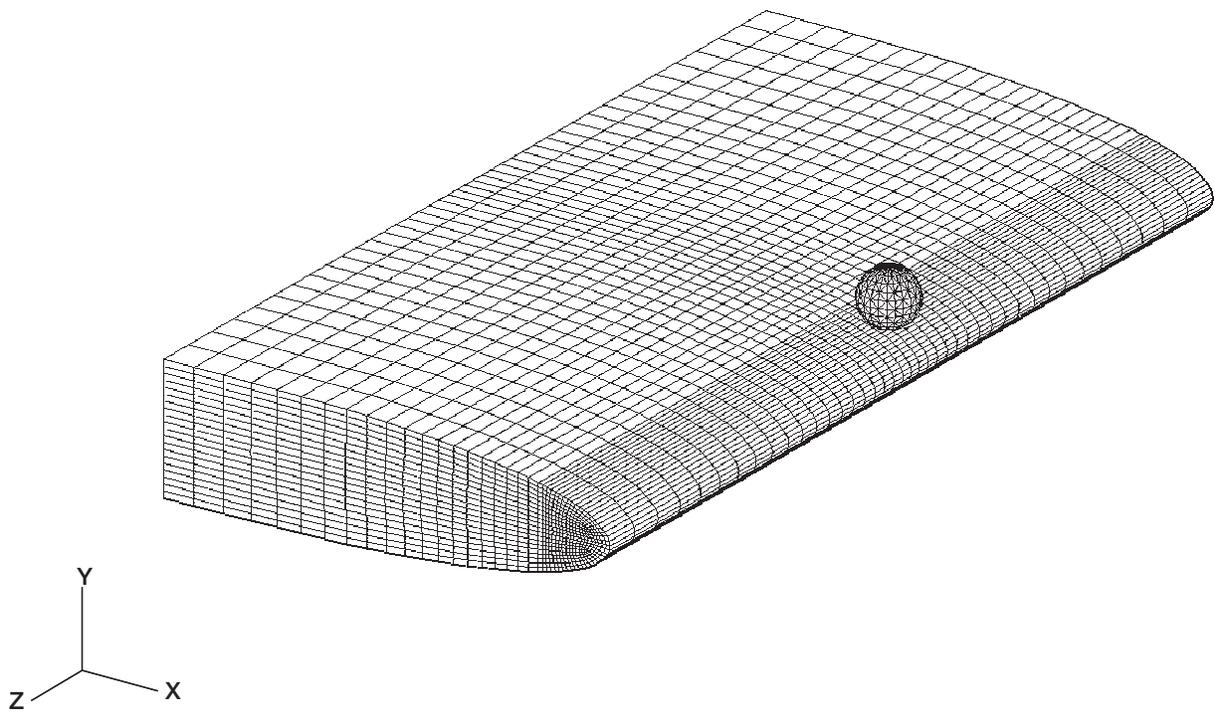
Figure 11.—Finite-element model of specimen 008-10-3 and 1.6-mm spherical projectile.

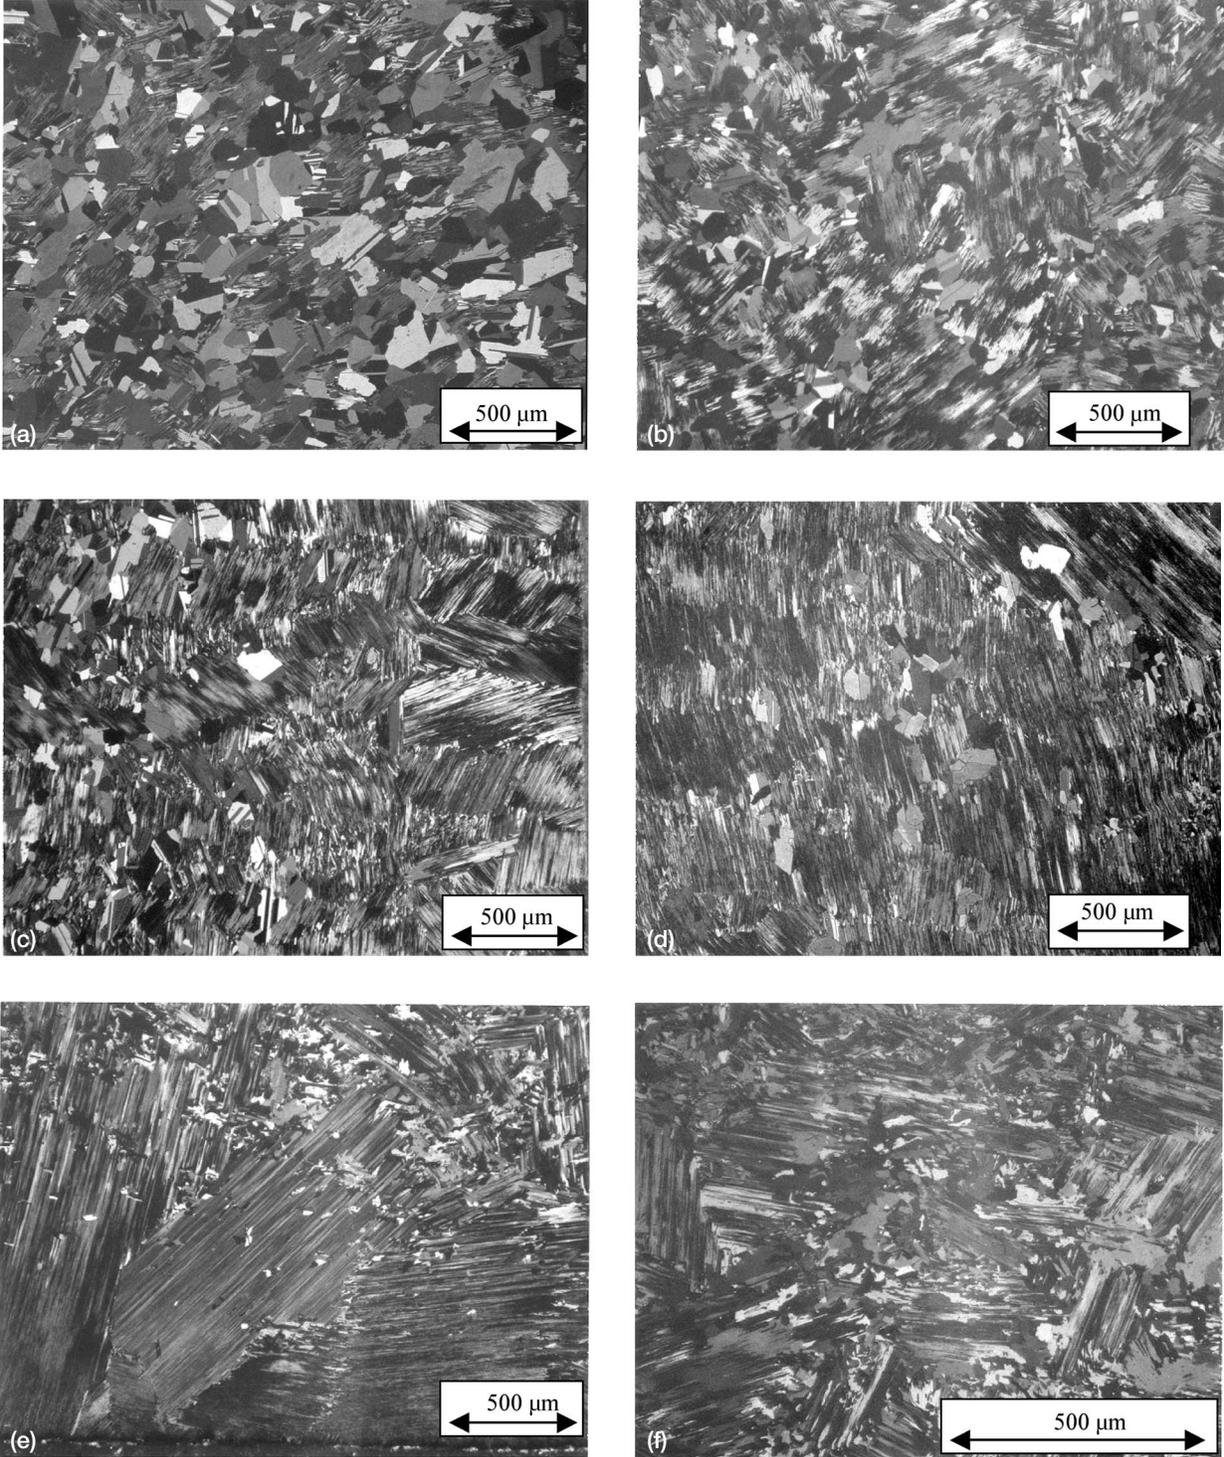
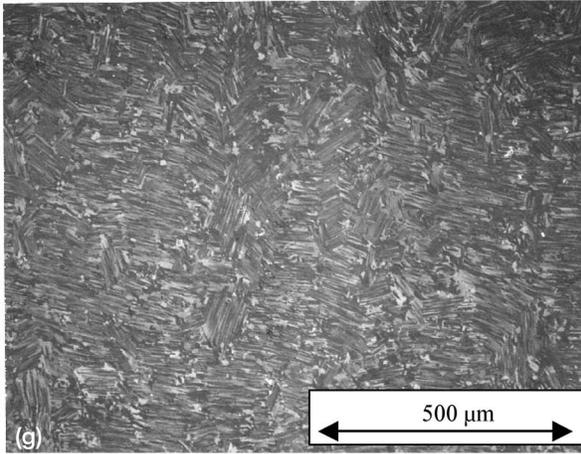
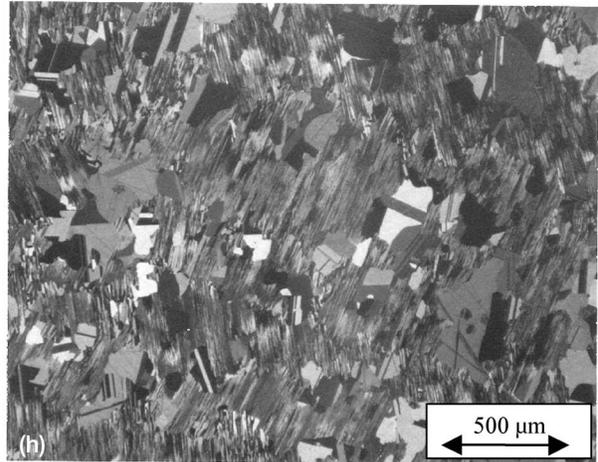
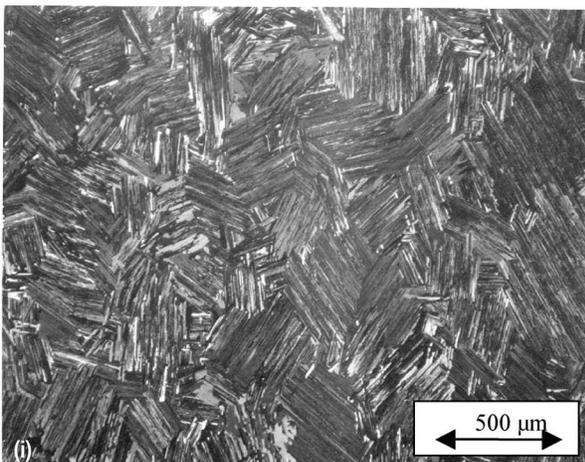
Figure 12.—As-received microstructure. (a) Cast-to-size Ti-48-2-2. (b) GEAE Ti-47-2-2, cast and machined. (c) CMU Ti-47-2-2 low aluminum, cast and machined. (d) Howmet Ti-47-2-2, cast and machined. (e) Cast-to-size ABB-2, near edge. (f) Cast-to-size ABB-2, center. (g) ABB-23, cast and machined. (h) NCG359E, cast and machined. (i) 95A, forged and machined.

Figure 12.—Concluded. (g) ABB-23, cast and machined. (h) NCG359E, cast and machined. (i) 95A, forged and machined.

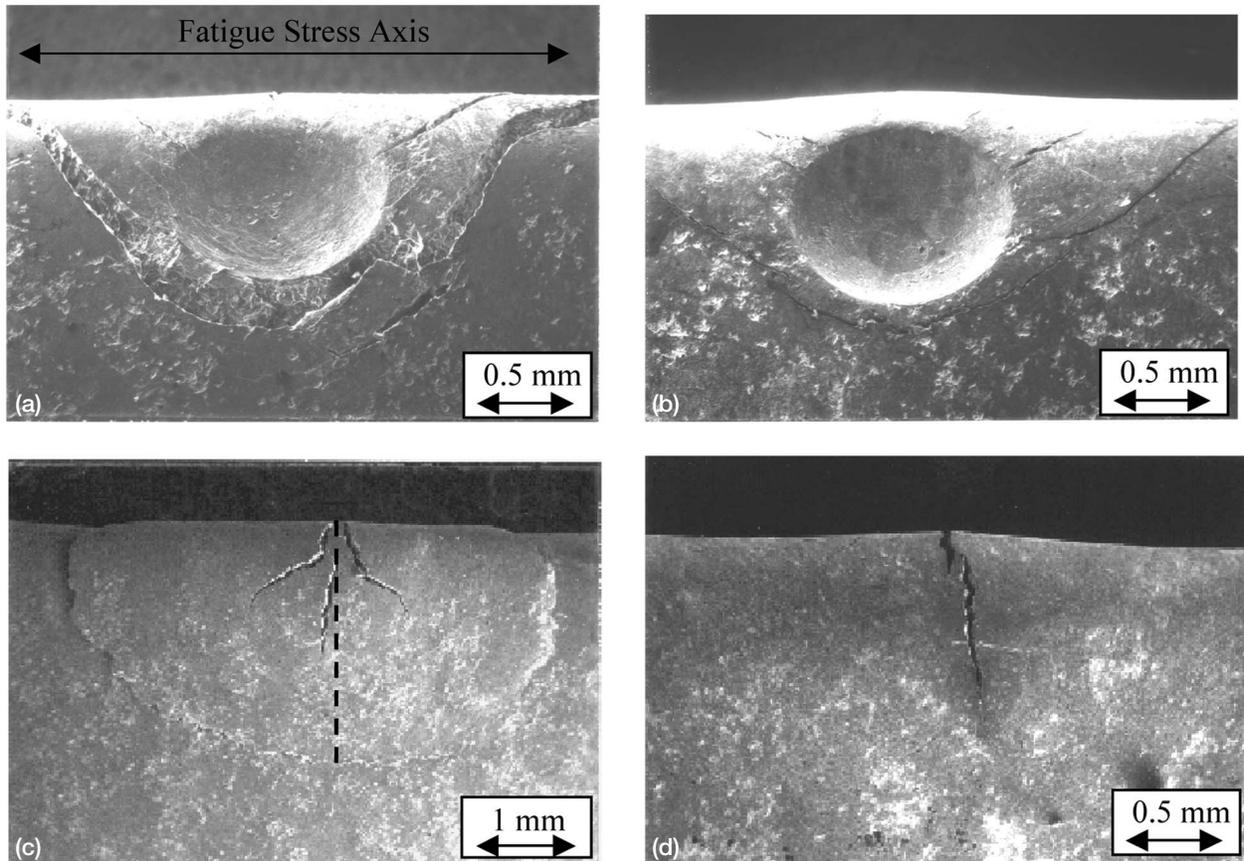
Figure 13.—Front and corresponding back-side damage after impacting cast-to-size Ti-48-2-2 with 0.33 J of energy. Fatigue stress axis is parallel to specimen edge and perpendicular to back-side cracks. (a) Front of thin sample. (b) Front of thick sample. (c) Back side of thin sample. (d) Back side of thick sample. All impacts used 1.6-mm projectiles. Thin samples, (a) and (c), were nearly blown out, and back-side straight crack length measurement for blowout or near blowout is demonstrated.

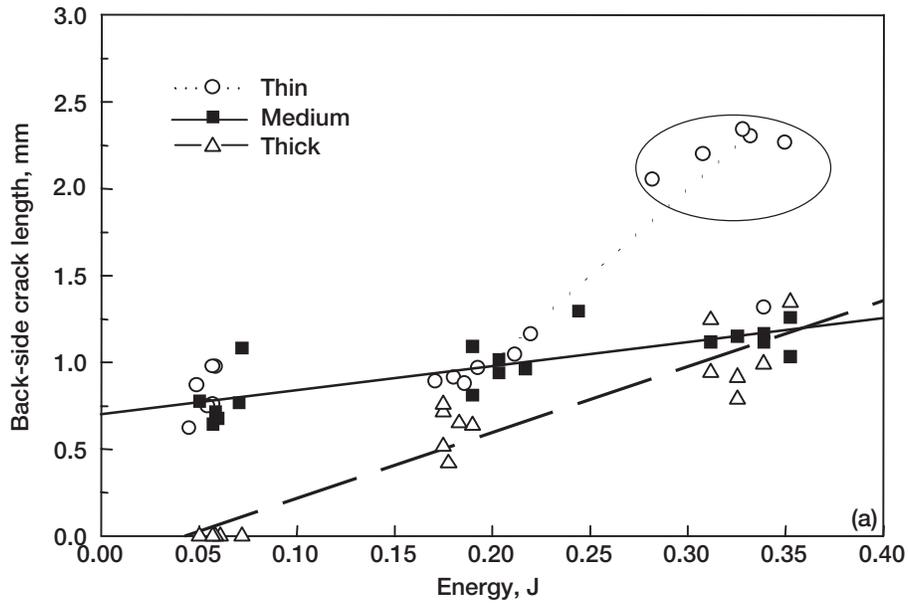
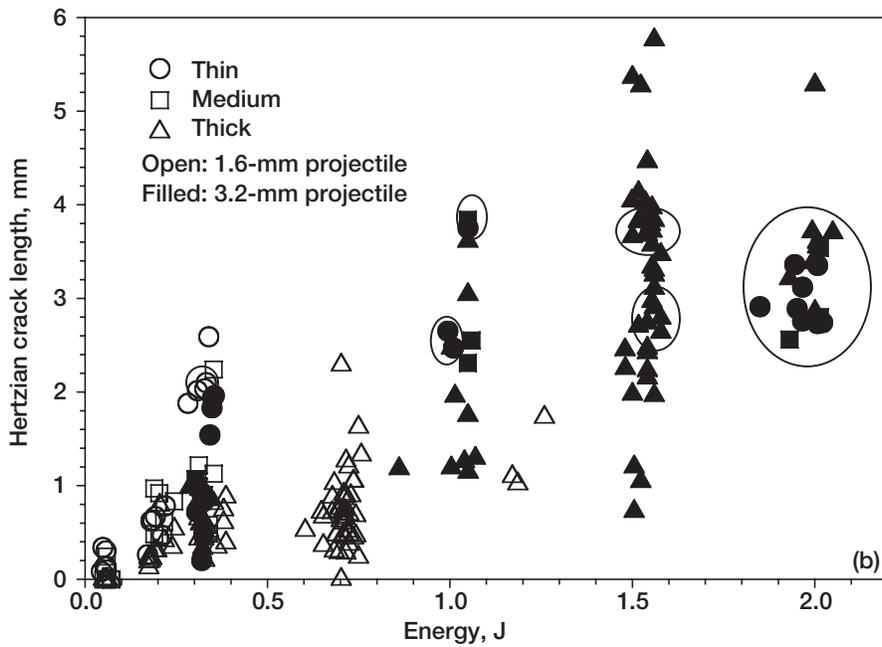
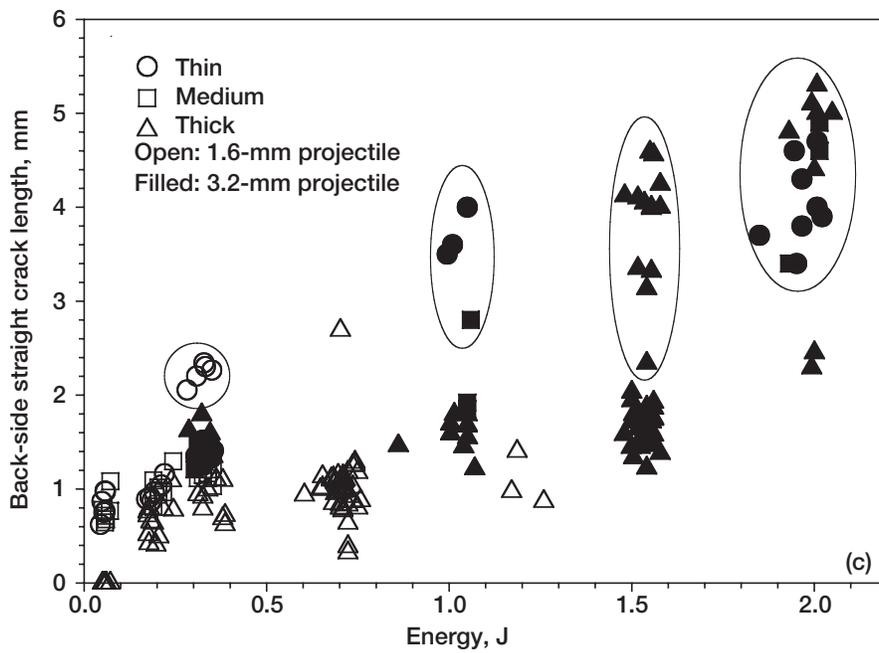
Figure 14.—Crack lengths for cast-to-size Ti-48-2-2 as function of impact energy. All samples impacted at 260 °C. Majority of data within circles are for blown-out specimens. (a) Back-side crack lengths for low-energy impacts. (b) Hertzian crack lengths over a wider impact energy range. (c) Back-side crack lengths over wider impact energy range.

Figure 14.—Concluded. (c) Back-side crack lengths over wider impact energy range.

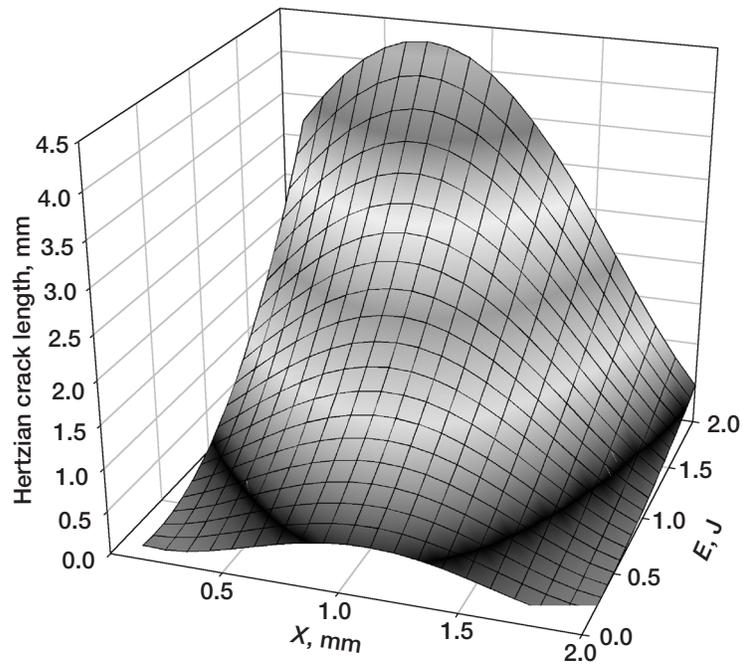
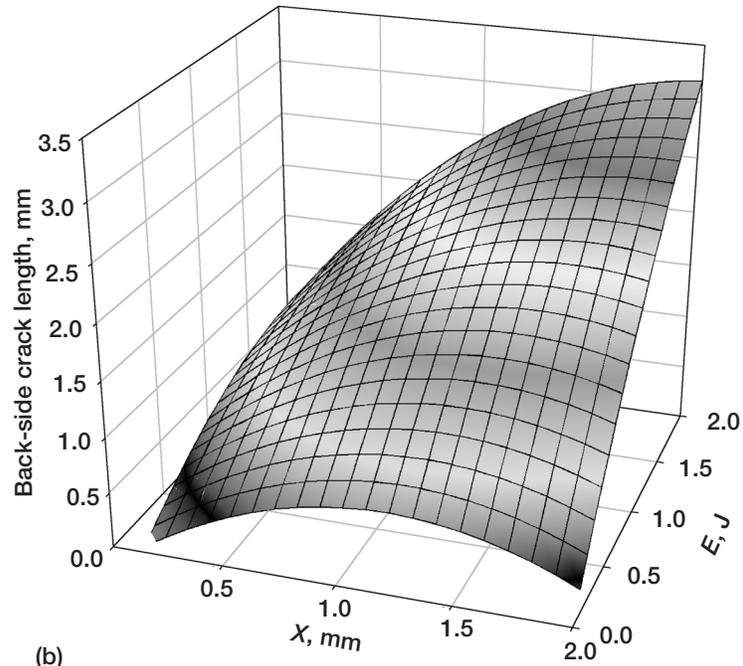
Figure 15.—Three-dimensional models depicting crack length as function of impact energy  $E$  and distance between impact and specimen edge  $X$ . (a) Hertzian. (b) Back-side. Models only valid for thick specimens impacted at 260 °C with no blowouts.

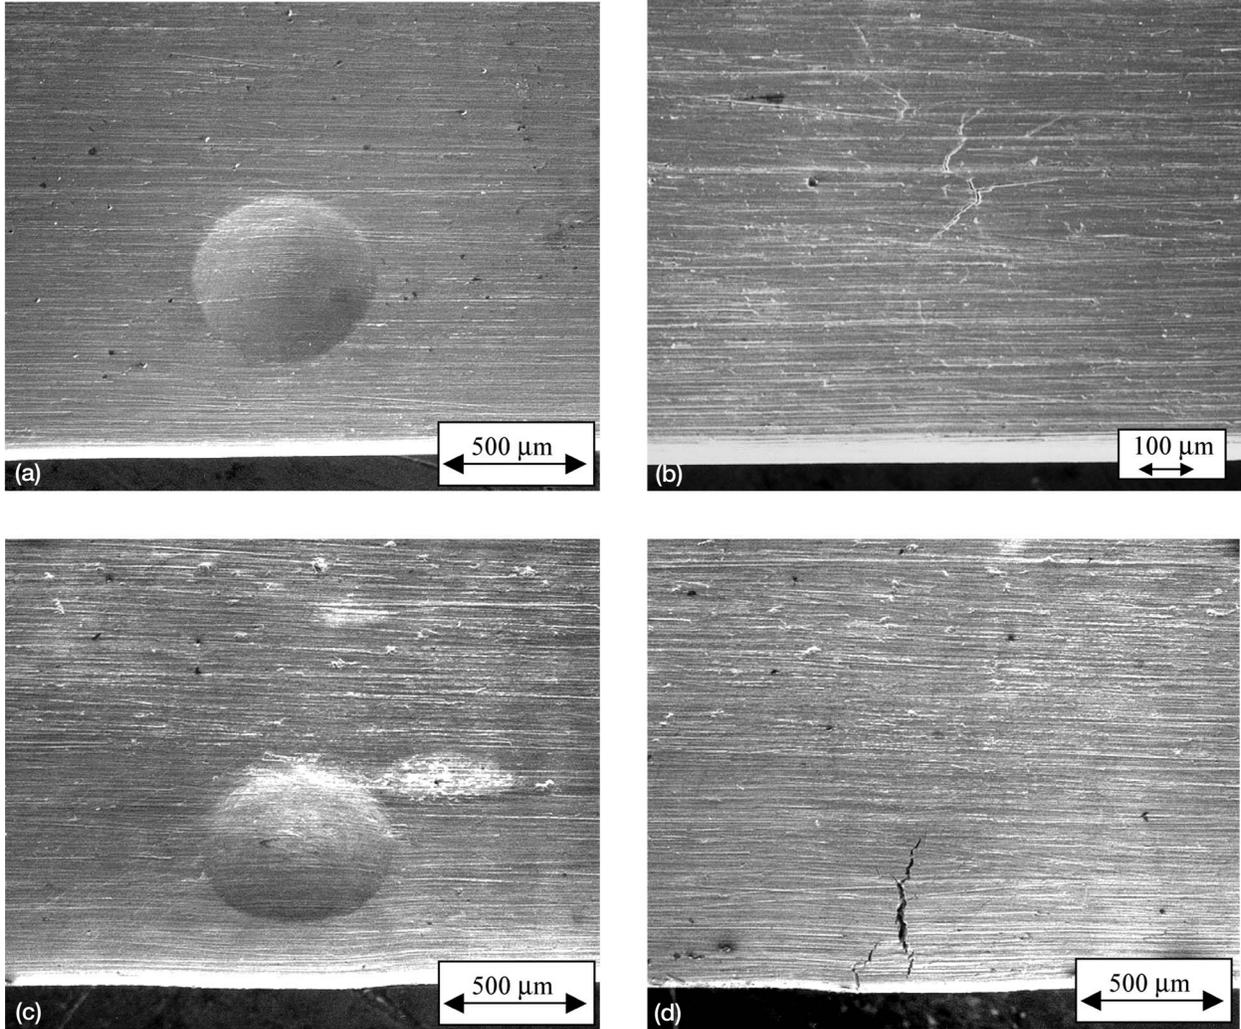
Figure 16.—Low-energy (0.06-J) impacts of machined GEAE Ti-47-2-2 samples. Little damage is on front side but variable damage on back side that was dependent on distance between impact and specimen edge. (a) Front-side damage. (b) Back-side damage. (c) Front-side damage. (d) Back-side damage.

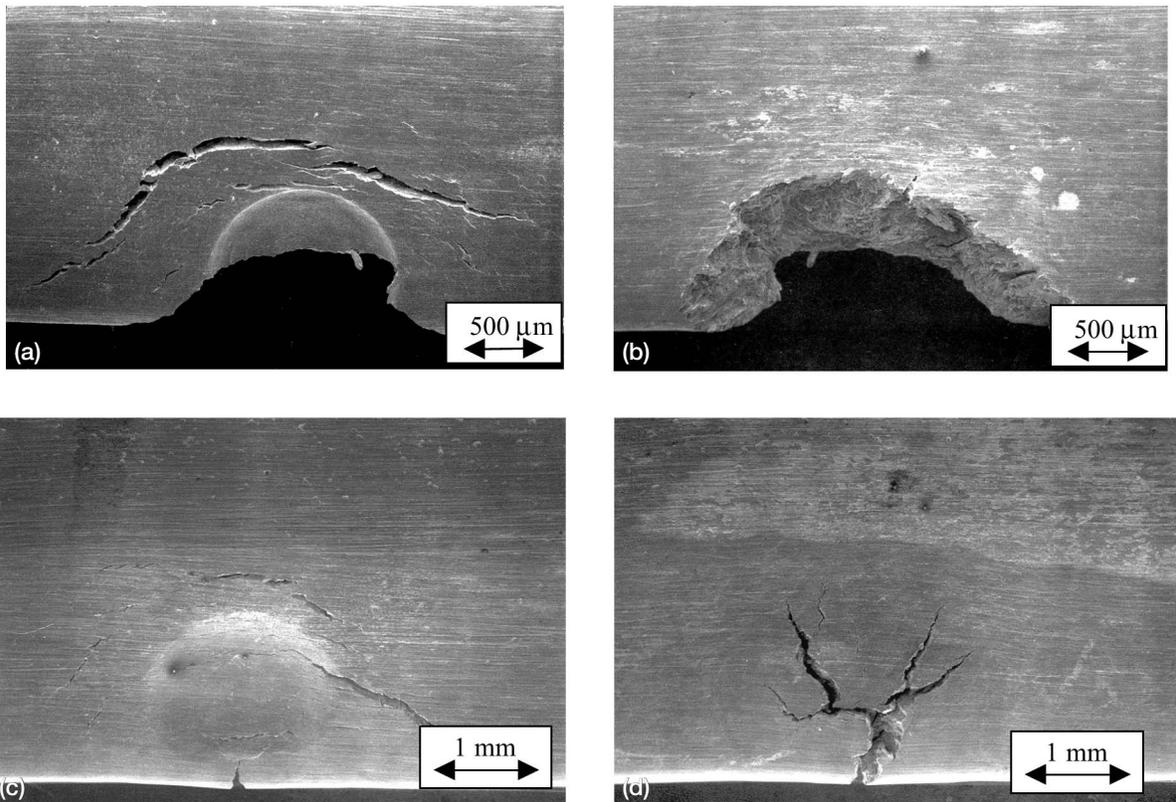
Figure 17.—Impact of machined GEAE Ti-47-2-2 sample. (a) Front side of intermediate-energy impact (0.79 J) with 1.6-mm projectile, showing partial blowout. (b) Back side of partial blowout. (c) Front side of high-energy impact (1.46 J) with 3.2-mm projectile. (d) Back side of high-energy impact.

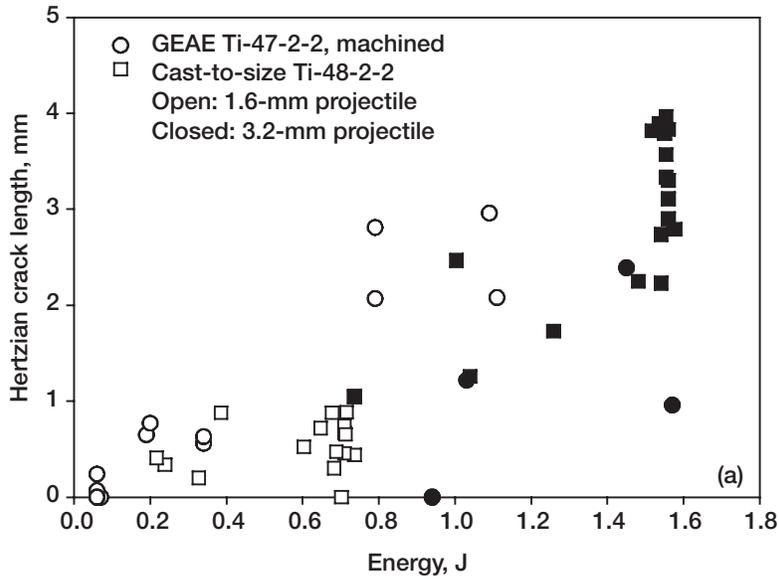
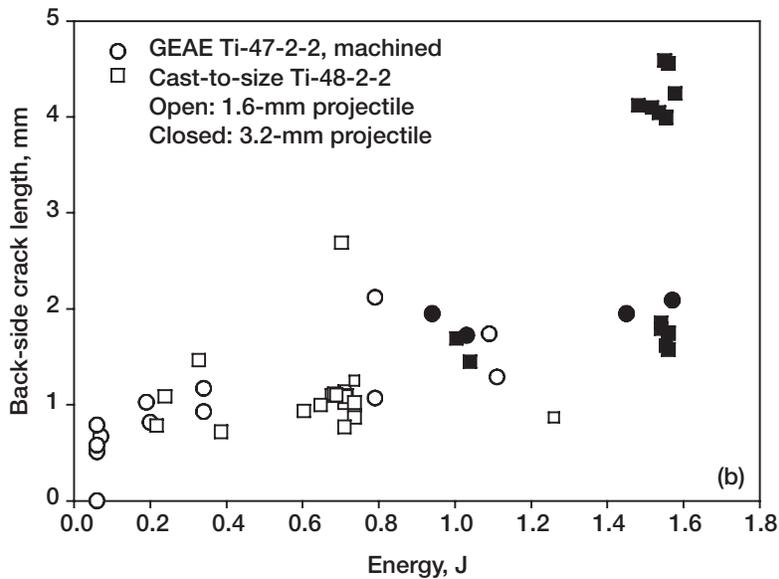
Figure 18.—Comparison of crack lengths as function of impact energy for machined GEAE Ti-47-2-2 and cast-to-size Ti-48-2-2 for different projectile sizes. (a) Hertzian crack lengths. (b) Back-side crack lengths.

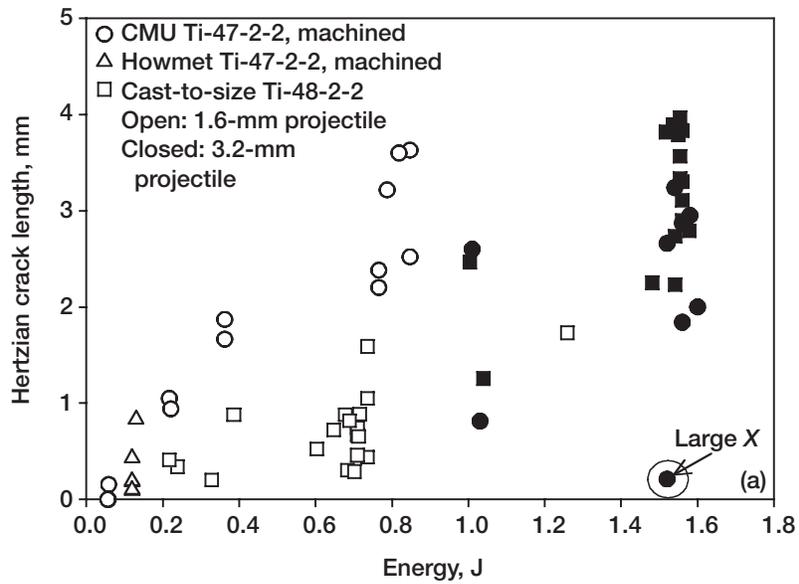
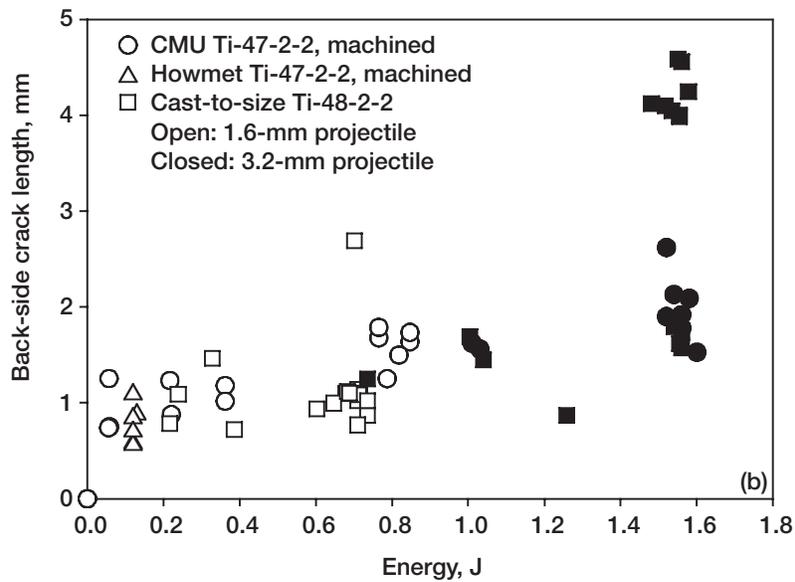
Figure 19.—Crack lengths of CMU Ti-47-2-2 and Howmet Ti-47-2-2 as function of impact energy compared with cast-to-size Ti-48-2-2 crack lengths for different projectile sizes. (a) Hertzian crack lengths. (b) Back-side crack lengths.

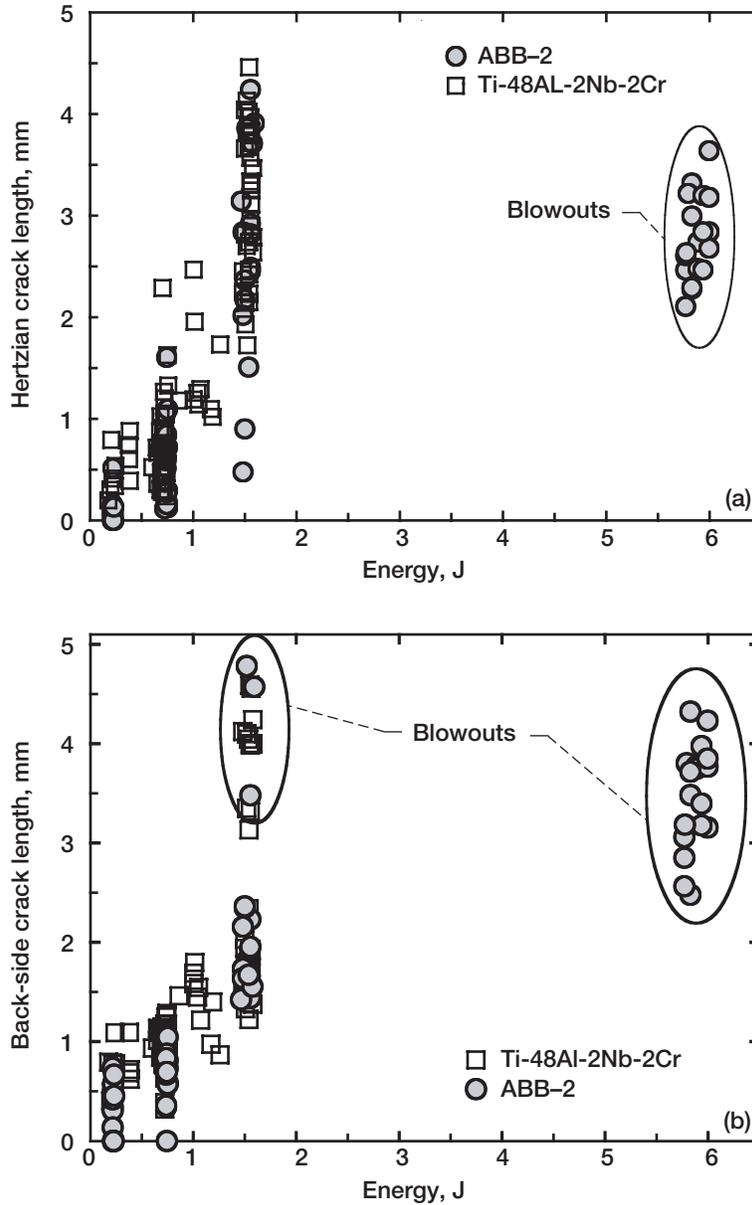
Figure 20.—Comparison of crack lengths of ABB-2 and cast-to-size Ti-48-2-2 as function of impact energy. (a) Hertzian crack lengths. (b) Back-side crack lengths. Some impacts were blown out at 1.5 J of energy, as indicated in (b), but could not be circled in (a) as the blowouts were scattered within the data, and the Hertzian cracks ranged in length from 2.3 to 4.0 mm.

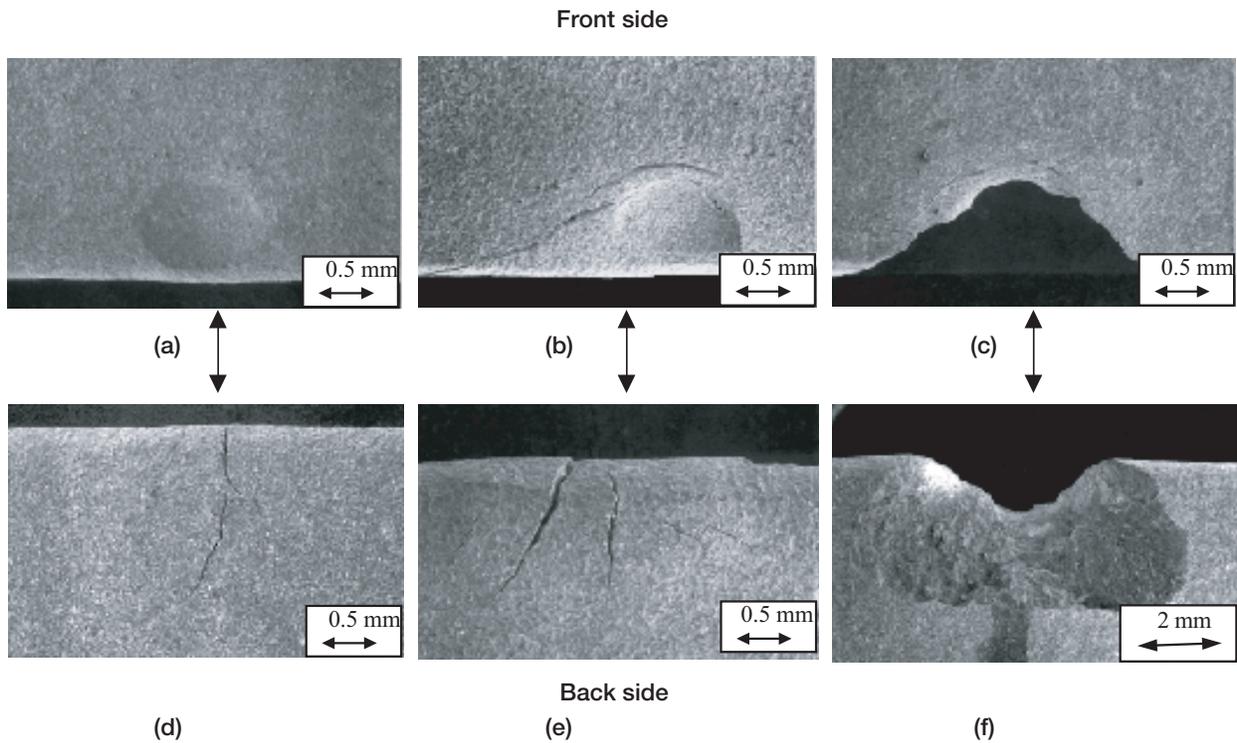
Figure 21.—High-energy (1.5-J) impacts for ABB-2 alloy. (a), (b), and (c) Wide range of front-side Hertzian crack lengths (0.48 to 3.1 mm). (d), (e), and (f) Corresponding back-side crack lengths, which are more consistent. Front and back side of blowout are shown in (c) and (f), illustrating half-cone shape of Hertzian crack.

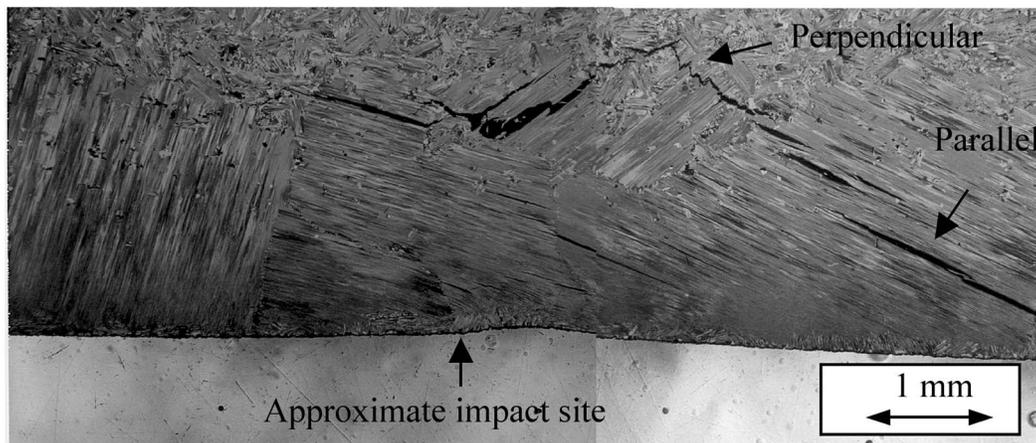
Figure 22.—Hertzian crack morphology in ABB-2 influenced by large lamellar grains near the sample edge. Hertzian cracks propagated easily parallel to lamellar grains but exhibited more torturous crack path when perpendicular to lamellar grains.

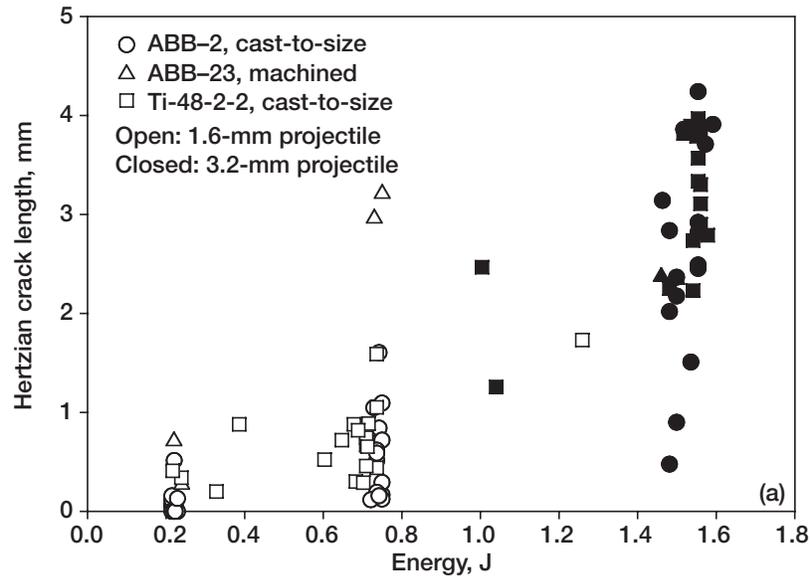
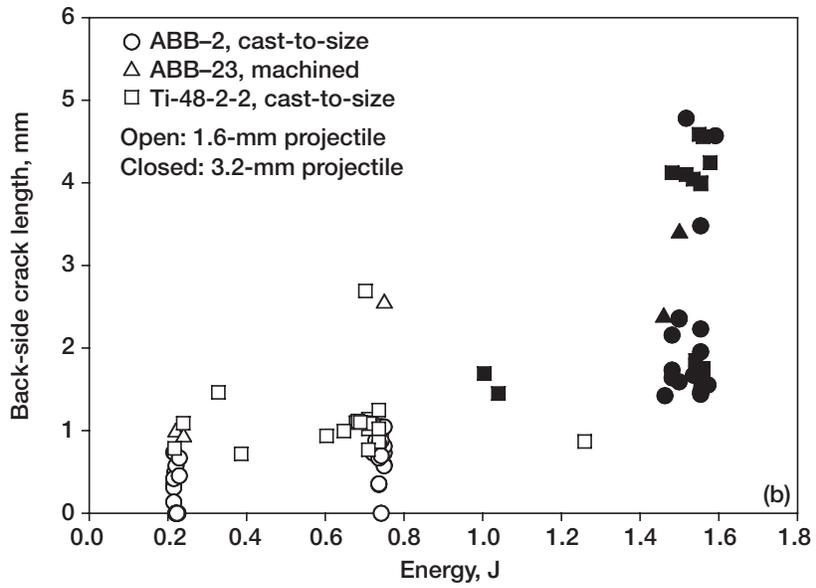
Figure 23.—Crack lengths of cast-to-size ABB-2, cast-to-size Ti-48-2-2, and machined ABB-23 as function of impact energy. (a) Hertzian. (b) Back side.

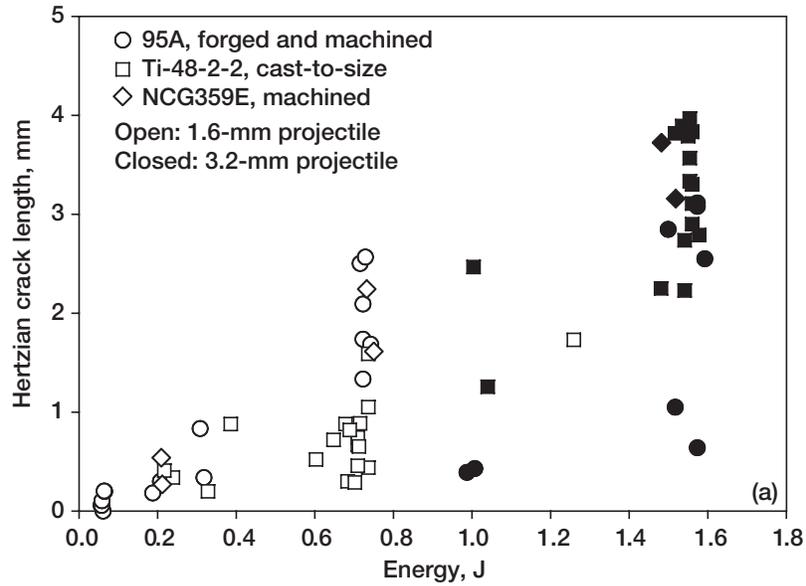
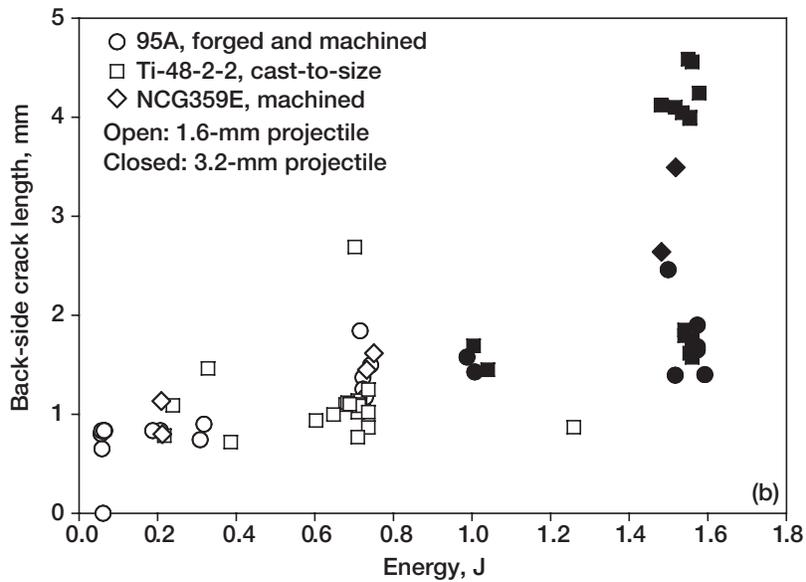
Figure 24.—Crack lengths as function of impact energy for machined 95A and NCG359E compared with cast-to-size Ti-48-2-2. (a) Hertzian. (b) Back side.

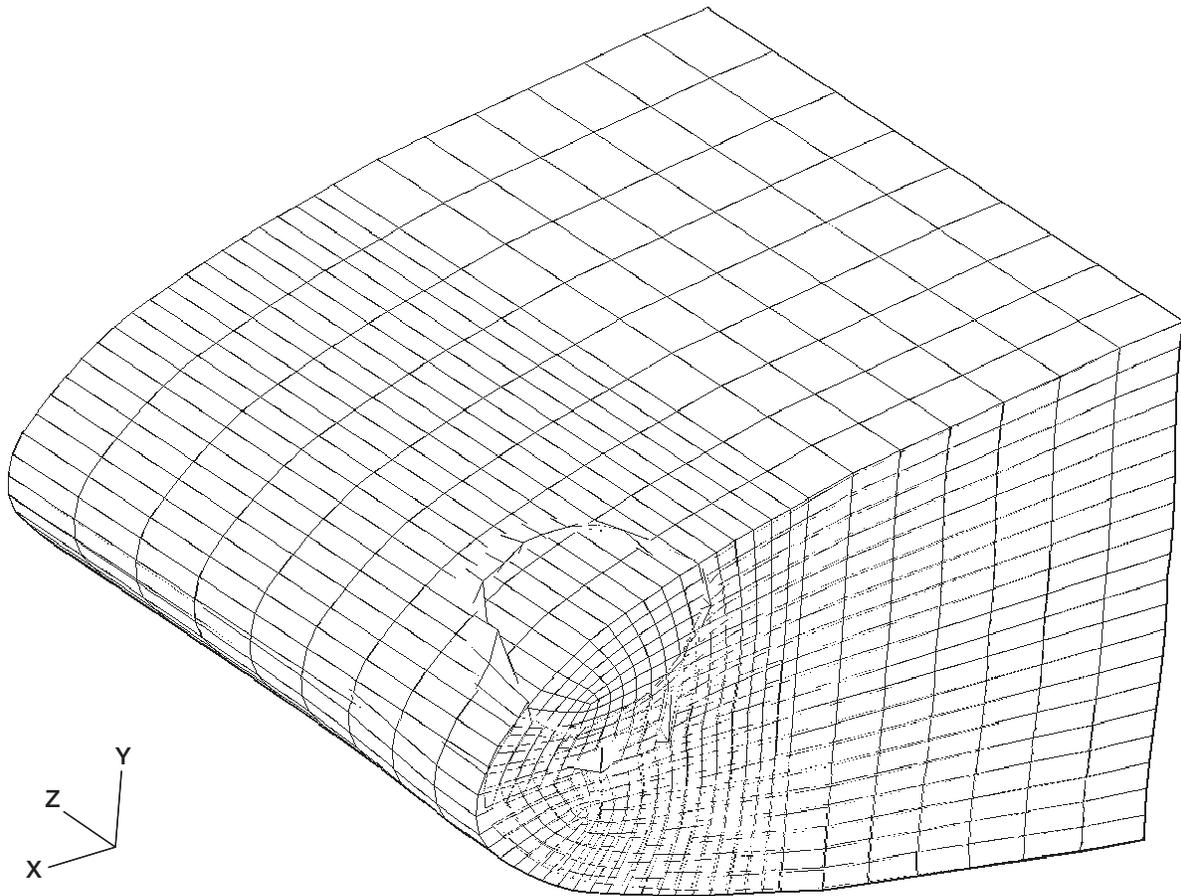
Figure 25.—Deformed shape of Ti-48-2-2 specimen 005-08-3. Bending in plane of specimen and in plane normal to it.

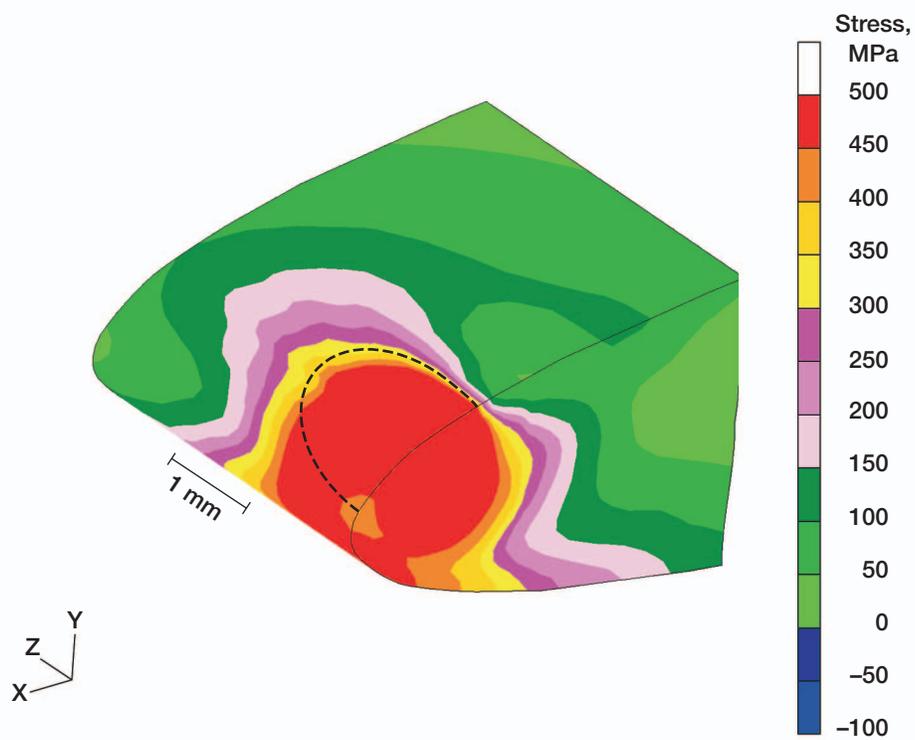
Figure 26.—Prediction of von Mises stress on front side of Ti-48-2-2 after low-energy impact (specimen 008-10-3). Dashed line is cracking zone.
